149 Hudson Street

1985 Townwide Historic and Architectural Survey of Berlin, Connecticut. Survey # 63

HISTORIC RESOURCES INVENTORY
BUILDING AND STRUCTURES
 HIST-6 NEW 5/77

IDENTIFICATION		DESCRIPTION	
1. BUILDING NAME (Common) <u>Berlin</u> (Historic) <u>#063</u>			
2. TOWN CITY <u>Berlin</u>	VILLAGE	COUNTY <u>Hartford</u>

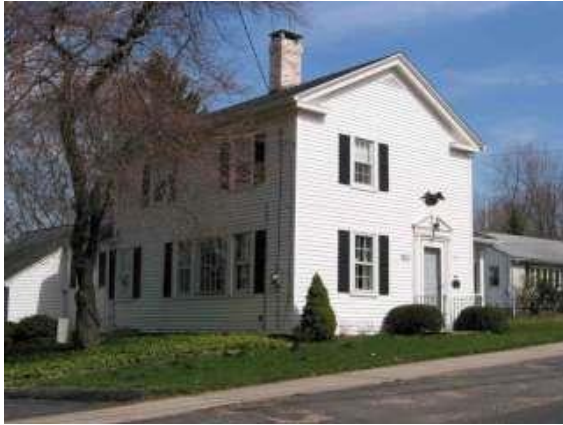
This house has a two-bay facade with a right entry. The trabeated entry has plain pilasters with molded capitals and a plain frieze topped by a molded cap. Windows are fitted with recent 6-over-6 sash; there is no second-floor window in the entry bay. There is a partially framed-in porch to the right, a new picture window on the left elevation, and a modern garage extension to the rear.

Although it is in excellent repair, this house retains almost no original exterior fabric. Nonetheless, it is significant as an example of the type of small, plain dwelling built throughout much of the 18th and early 19th centuries. Numerous alterations to this house, including changes in fenestration, a concrete-clad foundation, and the added porch and garage, make it extremely difficult to put a precise date on the building. The orientation of the house and the trabeated entry detail create an overall appearance of a small house from the Greek Revival period.
